## Point No Point Coastal Flooding

### Frequently Asked Questions

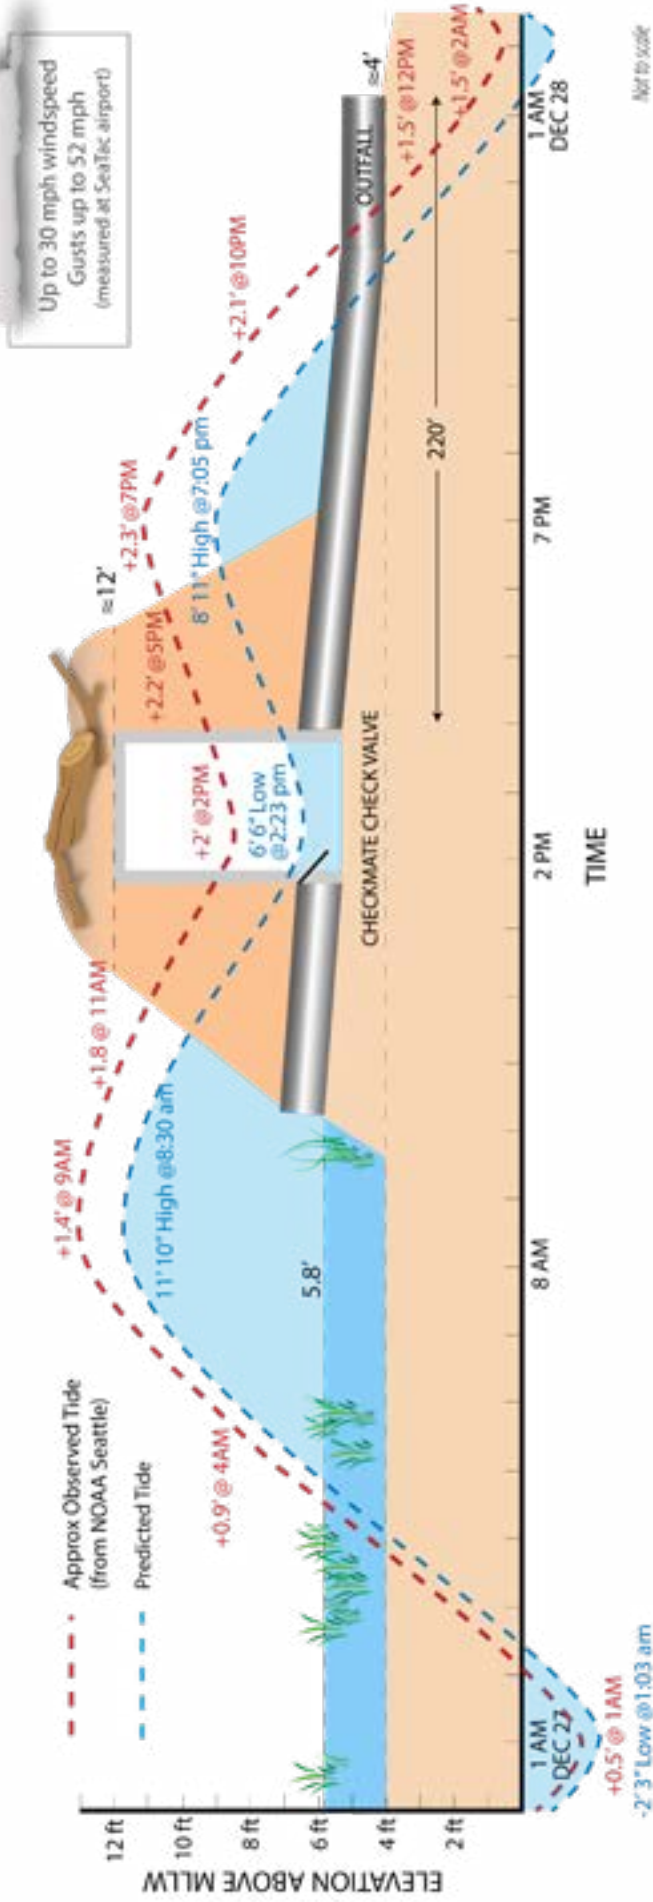
# POINT NO POINT TIDE GATE LOCATED IN EASTERN SHORELINE

Predicted tides and approx. observed water levels - December 27, 2022

The single discharge point for the impounded marsh is the tide gate in the eastern shore south of the lighthouse. The tide gate is set in an 18" diameter concrete pipe with the 18" outfall pipe extending 220 feet to the east, with the outfall elevation at around 4 feet of tidal height. The tide gate mechanism is a Checkmate Check valve rubber boot vs a hinged flap gate.

The flow line of the tide gate is at about 6 feet of tidal elevation, meaning that tide conditions above 6 feet provide back pressure on the tide gate and begin to restrict the flow. Thus, at higher tide levels, the check valve is completely closed to prevent tidal flow into the marsh. At low tides, the check valve opens to allow the freshwater marsh to flow out to Puget Sound.

The ditches, stormwater catch basins, and culverts have been inspected and are clear to flow within the tidal restrictions of the system. Water levels inside the marsh are regulated by the tidal elevations outside the marsh. Tidal elevations above 6 feet restrict the outflow from the tide gate and higher tides close the check valve completely.

The current tide cycle allows discharge through the tide gate for only about one-third of the 24-hour tide cycle.
